Summary of Recommended Changes to MND/IS

Historical and Cultural Resources

**GEOTECHNICAL ENGINEERING INVESTIGATION
PROPOSED NINE-LOT SUBDIVISION
50, 80, 88 FINGER AVENUE
APN 052-061-170, 180, & 200
REDWOOD CITY, CALIFORNIA**

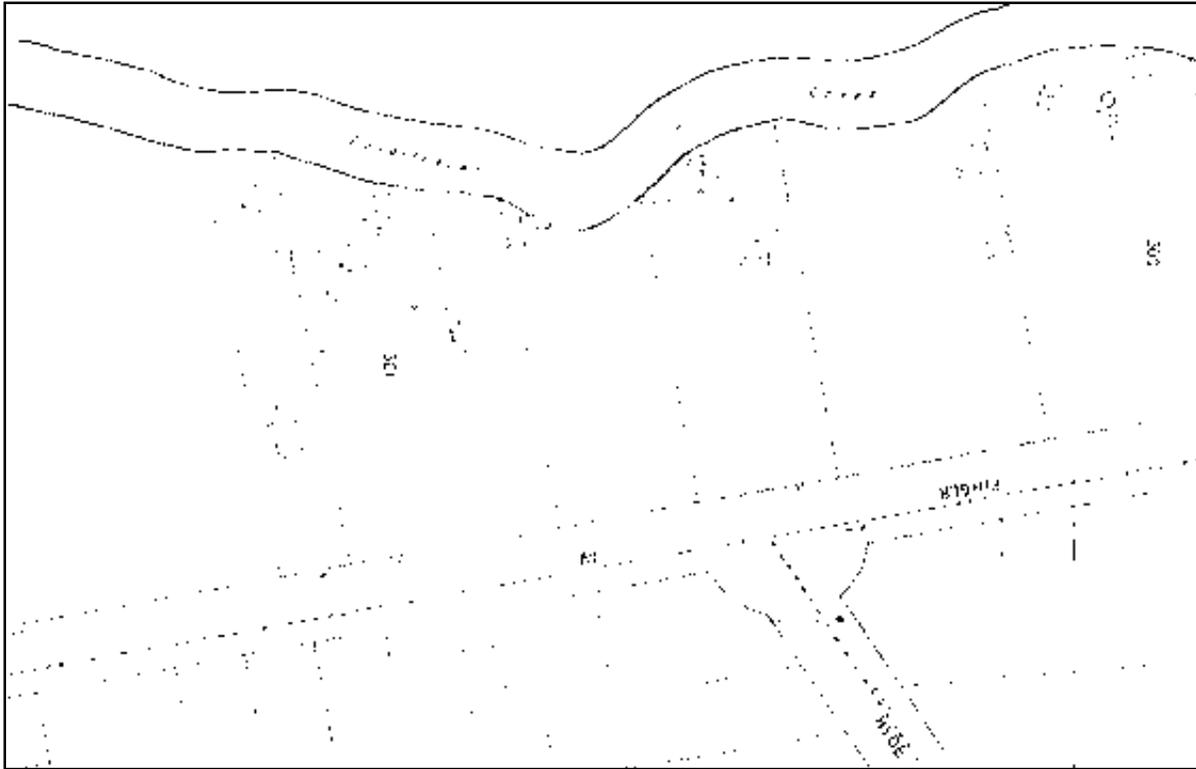
Figure 8: This 1919 Sanborn insurance map shows all of the buildings existing on the above lots. It is clear that the lots were originally sold in double, triple or even quadruple numbers; only two single lots existed on this stretch of Finger Avenue. An oak tree once stood in the semi-circle created at the junction of Hyde and Finger. The Finger farm house appears to have lost its western wing by the time of this survey.

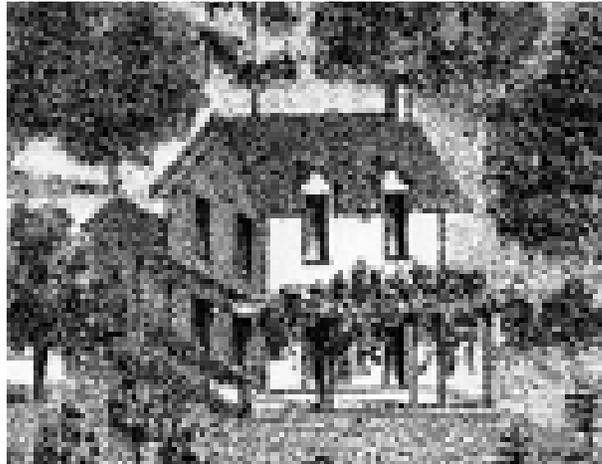
Figure 10: Detail of Moore and De Pue Drawing (full illustration in Fig. 1 above)

The illustration of the house drawn during the period of significance shows the main house with two sections: a steeply gabled two-story section and a cross-gabled one-story section on the western side. The two-story section has dormer windows on the eastern wall and the porch's awning roof is indicated (Figure 10). The front and east sides have four windows apiece, two on each floor, vertically aligned. There are no shutters on the windows in this illustration. This is the only known image of the house from the period; it is remarkably accurate in many aspects: the location of the dormers and chimney, the roof pitch and window size for example.

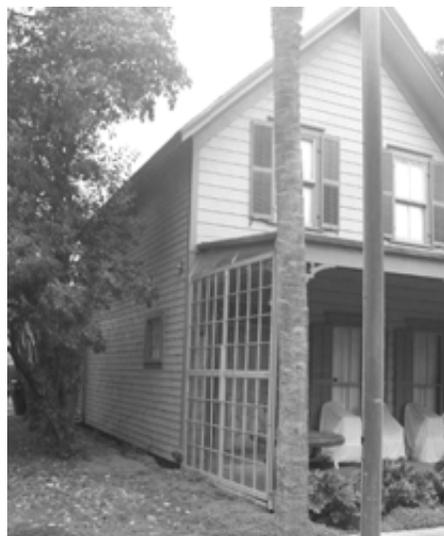
Figure 11: Shingles on western side where original house section was removed (side wall to left in photograph)

The property has suffered a number of losses since its period of significance: the orchards, vineyard, and farm outbuildings were removed when the property was subdivided in the early 20th century and the setting became suburban rather than rural. At some point prior to 1919, the western wing of the house was removed and the opening was patched with wood shingles in contrast to the board and batten siding of the original structure (Figure 11). At some time after 1919, additions were made to the building on the eastern and northern sides (Figures 12, 13, 14), disrupting the symmetry of these facades and destroying the relationship of the second floor windows to the roof dormers (Figure 15). The ground floor of the front façade (Figure 1) has two windows and a large door in the original house section and a smaller window and door in the addition on the eastern side. (The porch has been extended in front of the addition.)

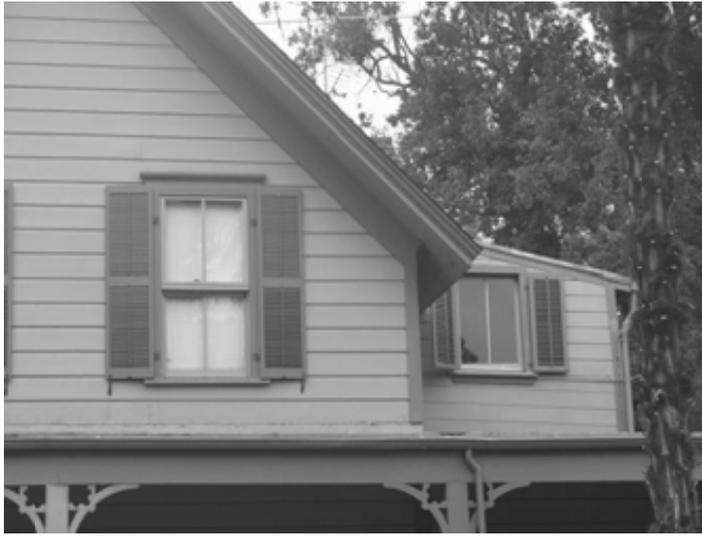
Figure 12: Detail of addition to eastern side (note change in window type)

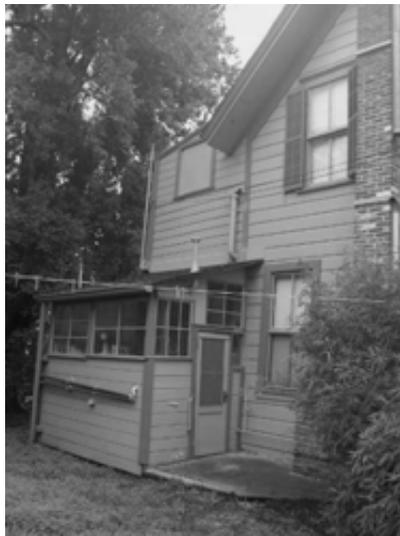
Figure 13: Addition to eastern side, viewed from rear of house

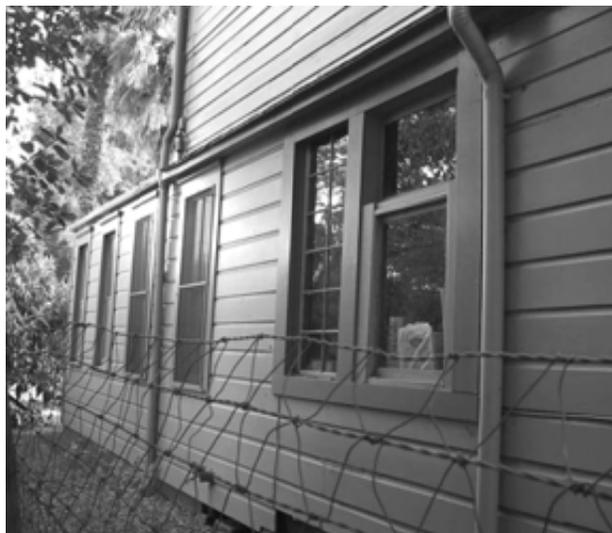
Figure 14: Ground floor, addition on eastern side

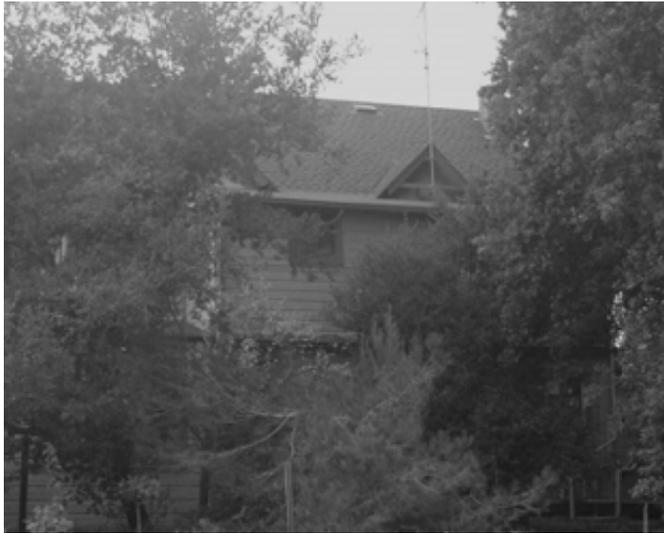
Figure 15: Dormers on eastern wall; windows have been moved

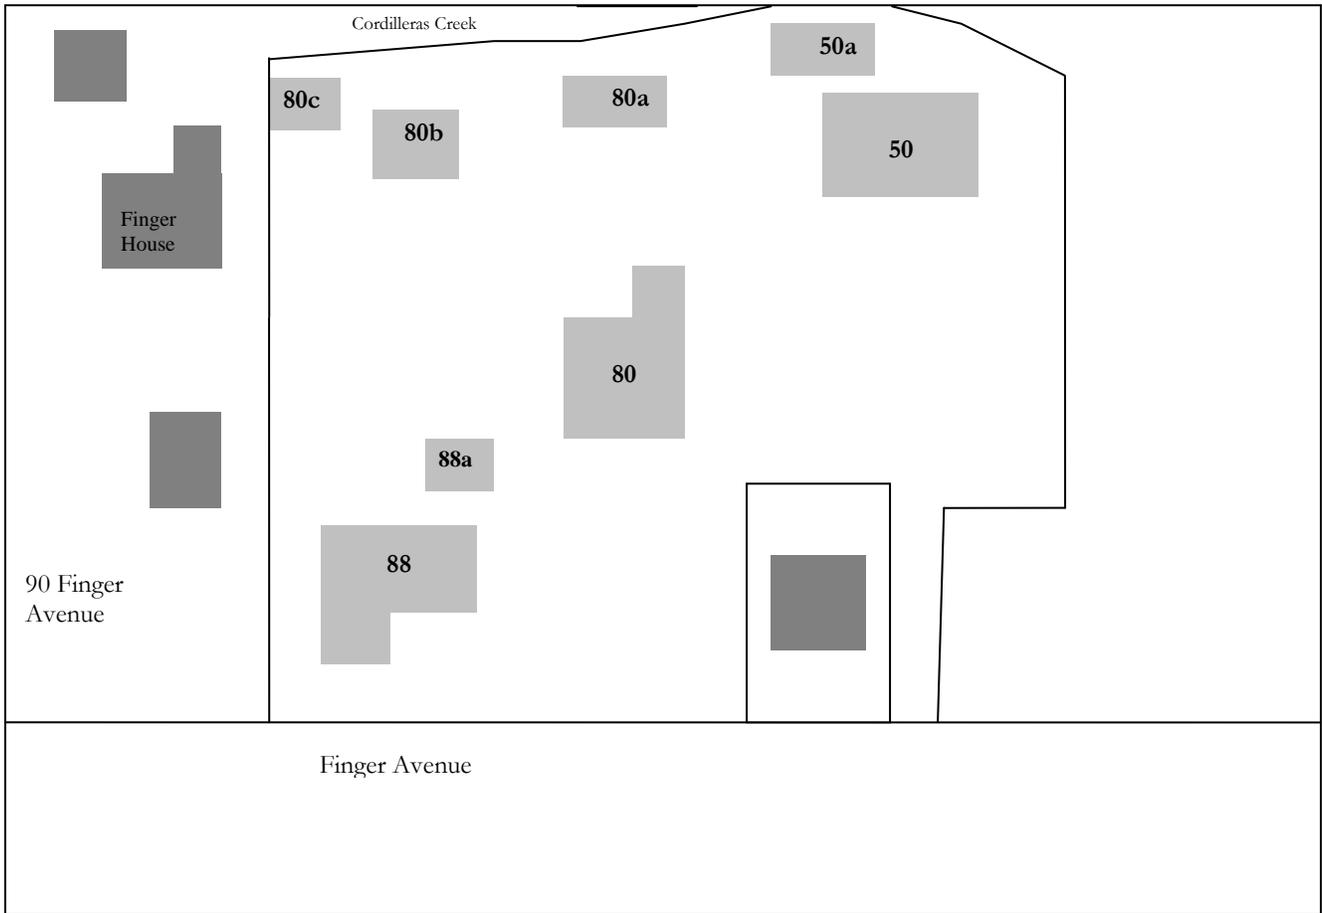
Figure 18: Map showing existing structures on the proposed project site (not to scale)

The two parcels that make up the site of the proposed project contain eight standing structures. A map and description of each of these appears below, indicated by house number.

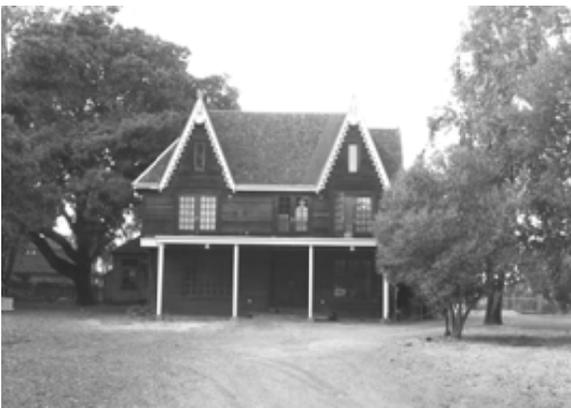
Figure 20: House at 50 Finger Avenue

The existing house at 50 Finger Avenue is of traditional style (eclectic gothic shingle chalet), but modern construction (post 1975). It is not of sufficient age or distinction to merit additional evaluation.

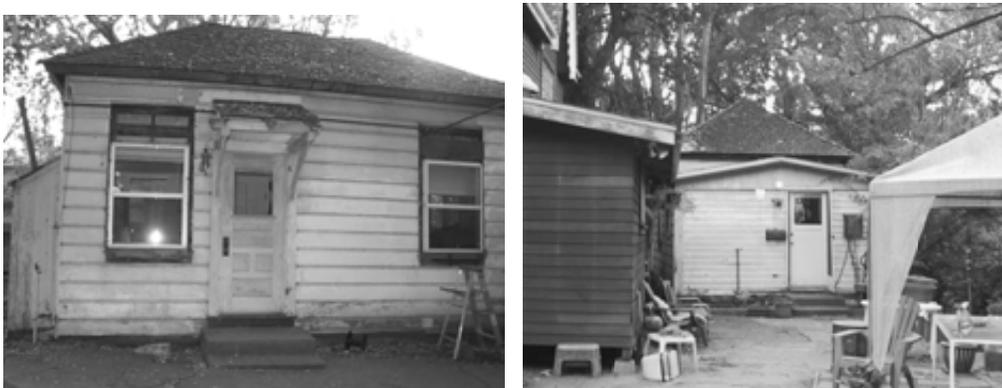
Finger 21: Existing cottage -- 50a Finger Avenue

City directories list two additional households on the property: 50a and 50b. This suggests that the cottage (440 sf) was continuously occupied and that in the 1950s a portion of the garage (430 sf) was converted to residential use. There is one surviving cottage on the site; from its location it appears to be the original cottage (50a). This is a simple, vernacular wood frame structure with clapboard siding and a hipped roof. The façade is asymmetrical, with the door off-center. The shed-roof entry and wood panel door are consistent with an early twentieth century date of construction; however, the windows have been replaced with aluminum frames in more recent years. The structure is in poor condition.

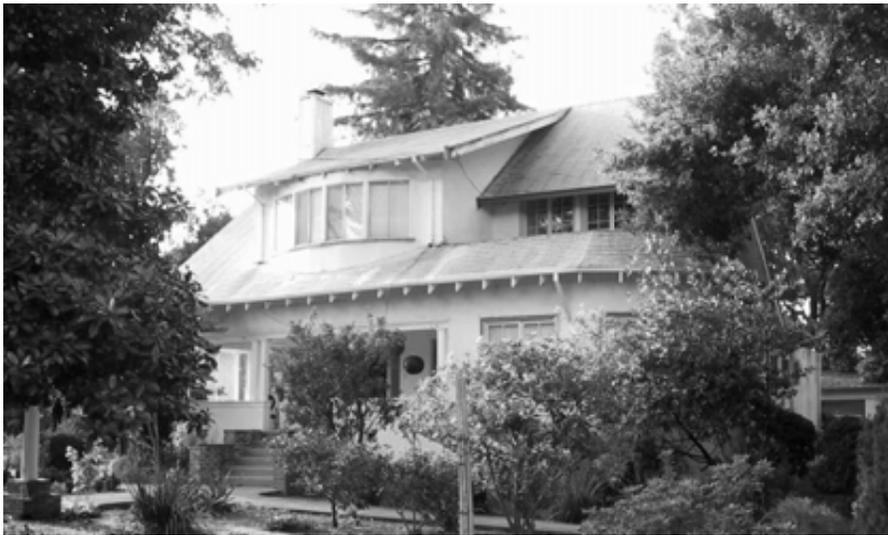
Figure 22: Front view, 80 Finger Avenue

Architecturally, the house is a weak example of eclectic craftsman or prairie style. Classic examples— of which there are hundreds in the local area — display wide eaves, decorative rafter braces and tails, massive and/or tapered porch columns — many have elaborated decorative detailing as well. The basic features of horizontal emphasis (evident on the front façade of this house but not the sides), overhanging eaves with exposed rafter ends, and a prominent entry porch are present in this gabled-roof example (lower pitched hipped roofs are more common for the style). The squared porch columns — doubled at the entry stairs — are a noted variant for the style. The bay windows, however, are less common.

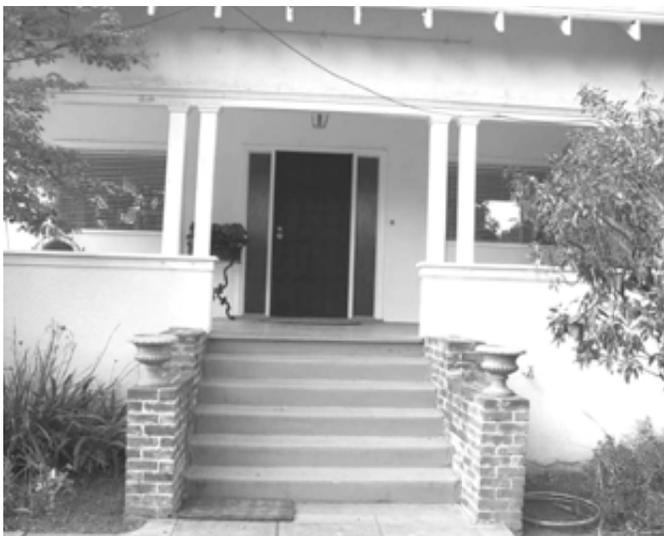
Figure 23: Front entry porch, 80 Finger Avenue

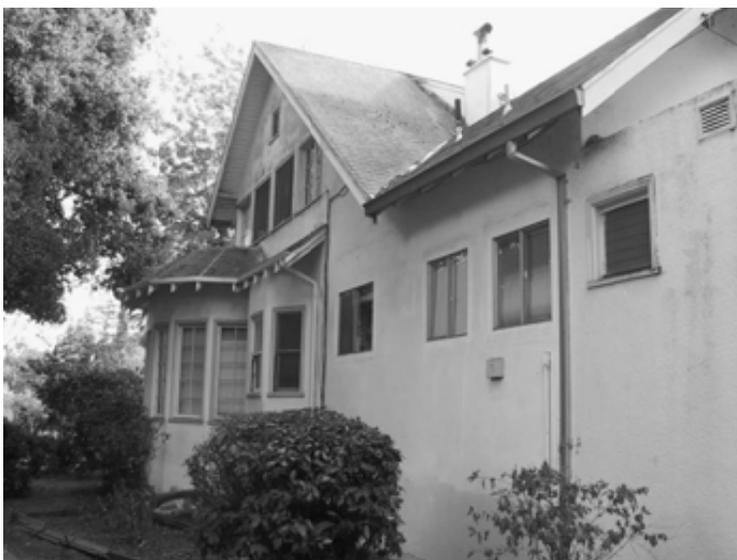
Figure 24: Right side view, 80 Finger Avenue, showing 1935 addition at rear

A substantial (2170 sf), two-story wood frame and stucco home was constructed on the property in 1931-32 by Dr. E.E. Richardson (who lived next door at 50 Finger Avenue in 1920). Dr. Richardson was an orthodontist who taught at the College of Physicians and Surgeons in San Francisco and had an office on Stockton Street in the city. In 1935 a “maid’s room” was added to the rear of the house. In 1937 it is shown as vacant, with new occupants from 1939-41 (Samuel and Ruby Saboff), 1946-48 (Albert and Carolyn Larsen), and 1950-58 (John Baross, listed as a supervisor at the San Francisco Post Office). 80 and 88 Finger Avenue were under the ownership of the Baross family until the current owner’s recent purchase.

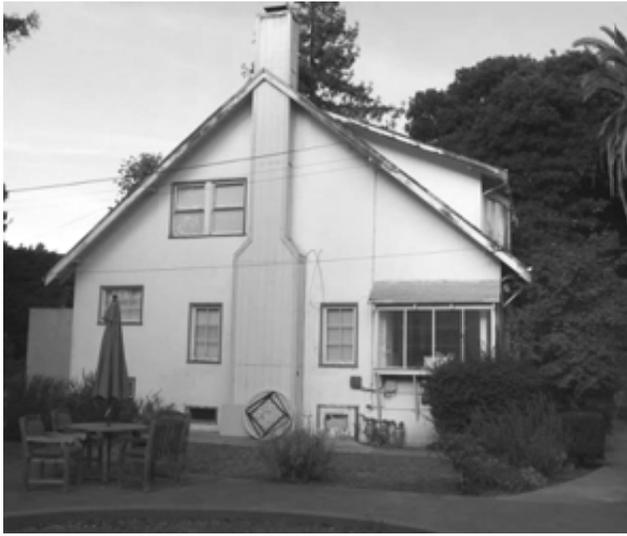
Figure 25: Left side view, 80 Finger Avenue

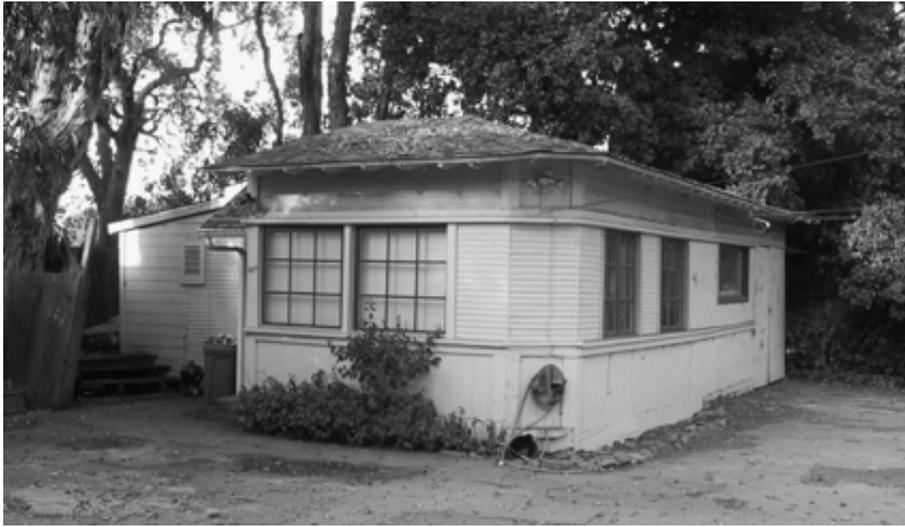
Figure 26: Cottage and garage, 80a Finger Avenue

This is a three-room cottage and attached garage located immediately to the rear of the house at 80 Finger Avenue. The style is vernacular and displays an oddly angled corner and at least three types of wood clapboard siding. The windows are square, nine-paned casement style, consistent with a construction date in the 1920s or 1930s. They are notably square in form — different in style from the windows on any of the neighboring structures. (In fact, each structure has slightly different window forms, suggesting different periods of construction.) The roof is hipped with modestly overhanging eaves and exposed rafter ends. The entry is concealed in the rear of the building.

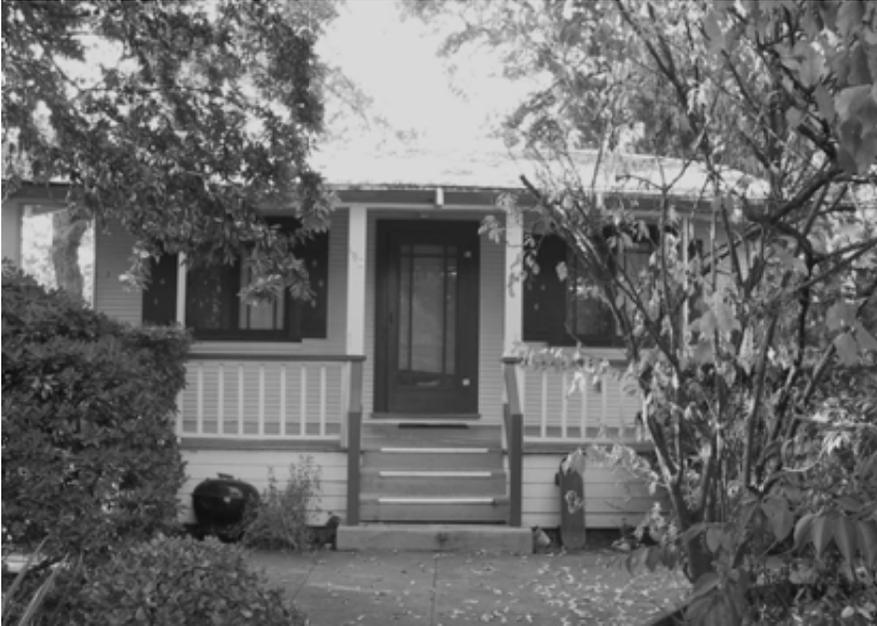
Figure 27: Cottage, 80b Finger Avenue

Shown on the assessor's parcel record for 88 Finger Avenue, the construction date of this cottage is unknown. It is a wood frame, clapboard siding, side gabled cottage that shares some stylistic features with the neighboring buildings: exposed rafter tails, the square porch columns similar to those on 80 Finger Avenue, and the narrow horizontal clapboards that recall the central "band" on the 80a Finger Avenue cottage. 80b Finger Avenue is actually displays yet another variation on window styling with craftsman style picture windows and a glass front door. The rustic wood shutters are unique as well. The strongly symmetrical façade is typical of vernacular craftsman forms, but quite different from its neighboring buildings on the site.

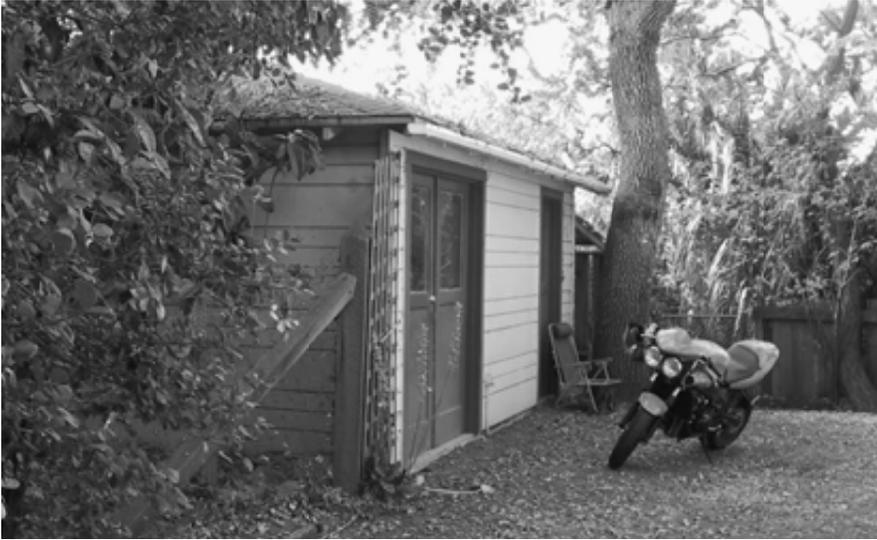
Figure 28: Shed adjacent to 80b Finger Avenue (80c)

Yet another combination of vernacular forms: a further variant on clapboard siding, a carriage-style door and a hipped roof. It displays the shallow overhanging eaves (and short rafter tails) characteristic of other buildings on the property. Its construction history and use are unknown. This structure does not meet the criteria for landmark listing either for its architectural style or for association with historic events or persons.

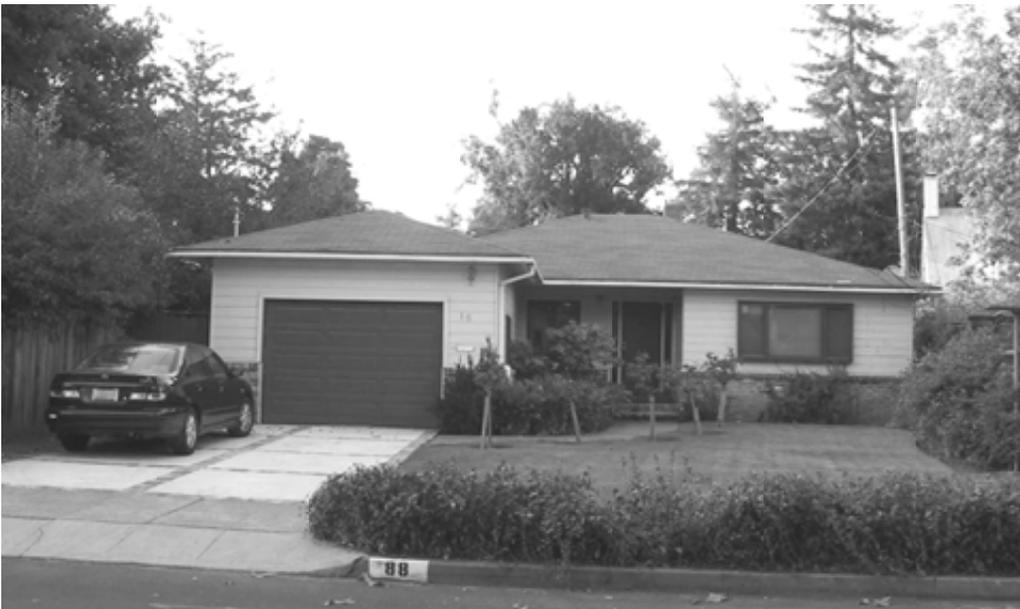
Figure 29: 88 Finger Avenue

This is a typical post-war house, constructed in 1949: modest in size, simple in design. It has a hipped roof, and the front is dominated by the single-car garage and picture window. It has horizontal clapboard siding and a brick masonry lower course that emphasize the horizontal dimension. Like the cottage to the rear, 80b Finger Avenue, this house has decorative wood shutters. Like its neighbor at 80 Finger Avenue, the front door is flanked by simple side lights.

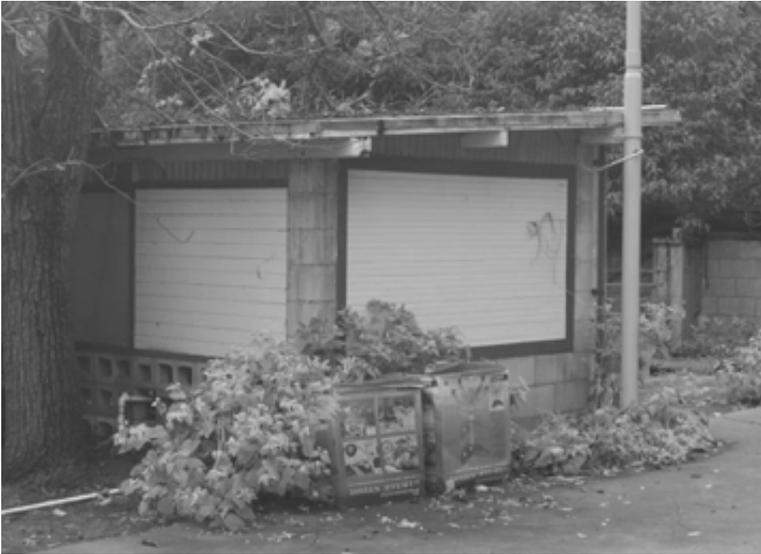
Figure 30: Shed at 88 Finger Avenue (88a)

There is a concrete block construction outbuilding sited on the lot line between 80 and 88 Avenue. The building has a sloping flat roof and roll-up metal awning windows. It is not shown on any assessor's maps and is clearly distinct in age and style from the wood frame structures surrounding it. It appears to house the water source for a small fountain in the garden of 80 Finger Avenue and may have been associated with other mechanical functions, perhaps a swimming pool that is no longer present on the site, or as a potting shed. The roll up awning windows recall a poolside "snack bar," and there is an adjacent brick barbecue structure. Its original function is unknown; it is currently used for storage.

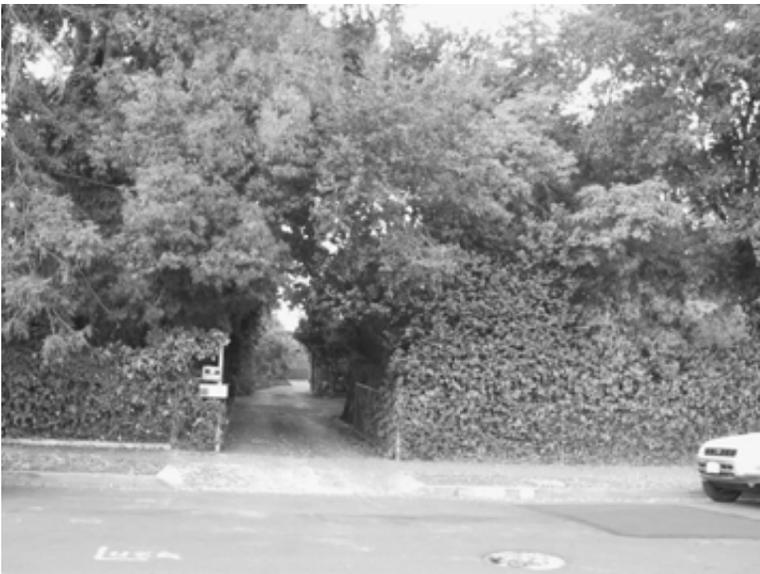
First, it is clear that the proposed project does not further diminish the visibility of the Finger Farm House. The barrier to public appreciation of this historic resource is the vegetation screening currently on the 90 Finger Avenue property, and the substantial setback of the main house from the street (more than 100 feet). The proposed new homes are no closer to the Finger Farm House than the existing structures at 80 and 88 Finger Avenue. Thus there is no adverse impact on the ability of the public to appreciate the Finger Farm House, a privilege they do not currently enjoy but would not be harmed in any case by the construction of the new homes.

Figure 31: View from public-right-of-way of 90 Finger Avenue

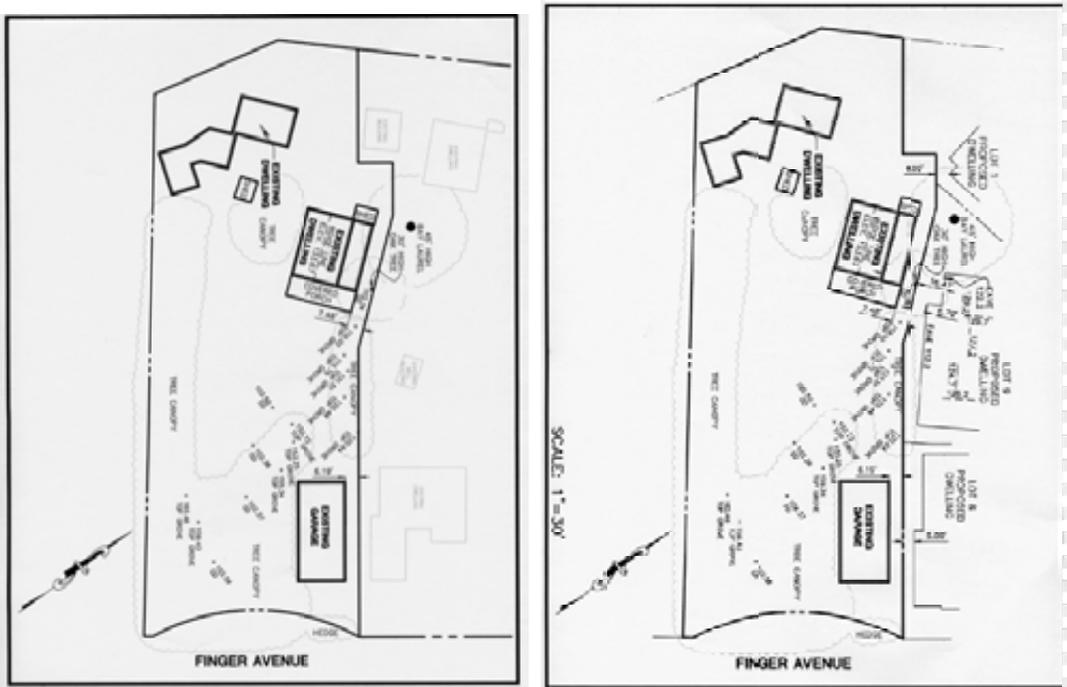
Figure 32: Site plan of Finger Farm House and Existing Structures (left) versus Proposed (right)

In its existing condition, the construction of new, two-story homes on the lots to the east of the Finger Farm House have no effect on its visibility from the public right-of-way because it is not now visible due to its distance from the street (nearly 170 feet), the intervening garage on the 90 Finger property, the house at 88 Finger Avenue, and the presence of large trees and hedges. Due to the depth of the lot, and the maturity and density of vegetation, it is highly unlikely that the new houses would be visually juxtaposed with the historic south façade of the Finger Farm House.

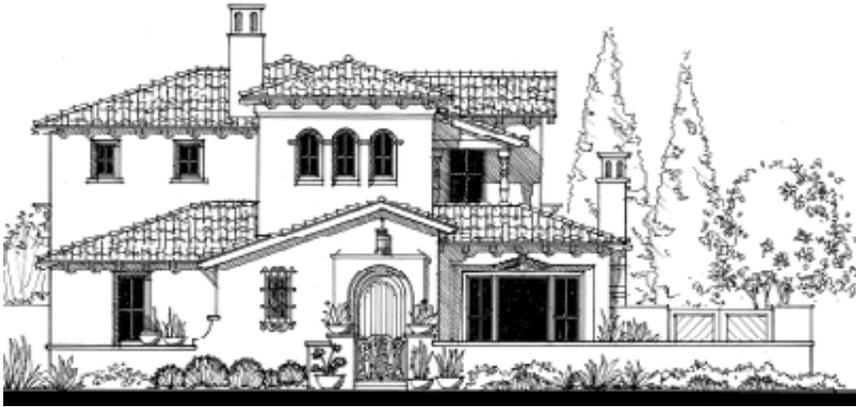
Figure 33: Street front view, proposed new house

The style of this home is Spanish Eclectic, which while in common in the neighborhood is not likely to be confused with rustic Gothic Revival. It is clearly distinct in style and materials from the Finger Farm House. Moreover, given the difference in street setbacks, even though they are “next door” it will be nearly impossible to see the two houses at the same time.

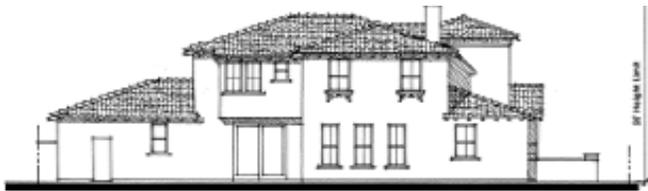
Figure 34: Rear elevation of proposed new house (adjacent to Finger Farm House garage)

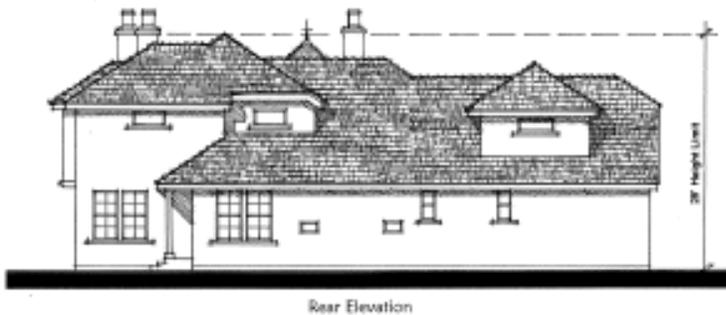
And the rear elevation of the house closest to the Finger Farm House along the lot line (the Finger Farm House is sited more than 100 feet back from the street edge on its lot):

Figure 35: Rear elevation of proposed new house, adjacent to Finger Farm House

The roof line of this house is likely to be visible from the front yard of the Finger Farm House, as is the existing home at 80 Finger Avenue. Given the amount of mature vegetation along the property line, this does not appear create a significant visual impact (see Figure 36 below).

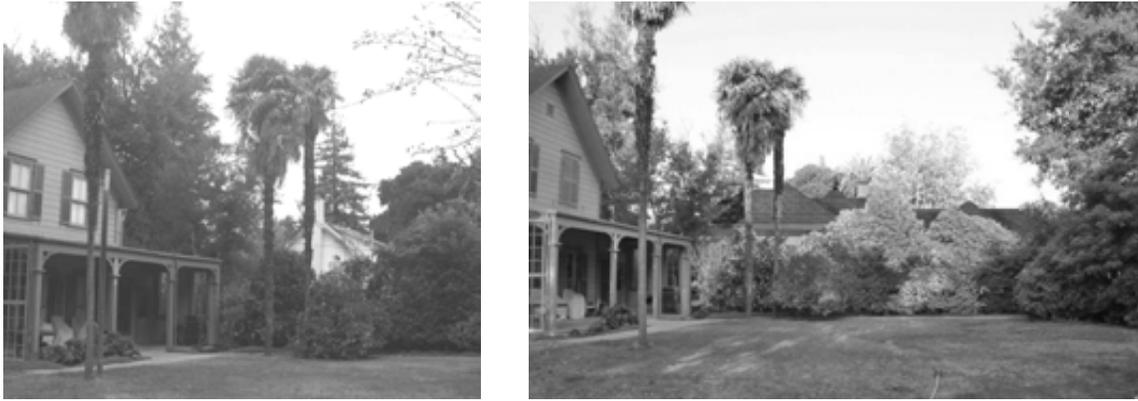
Figure 36: View of 80 Finger Avenue from 90 Finger Avenue now (left), simulation with proposed project (right)

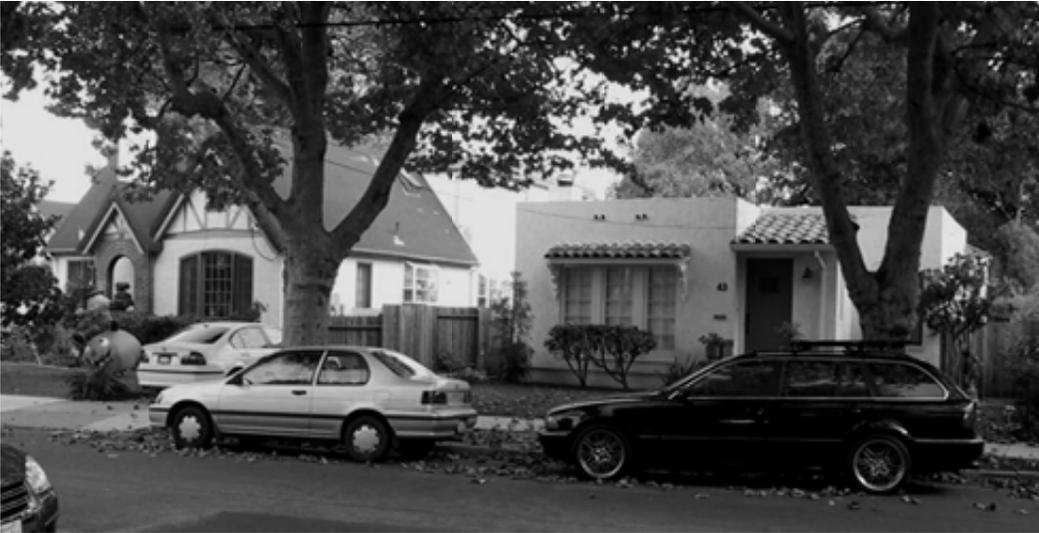
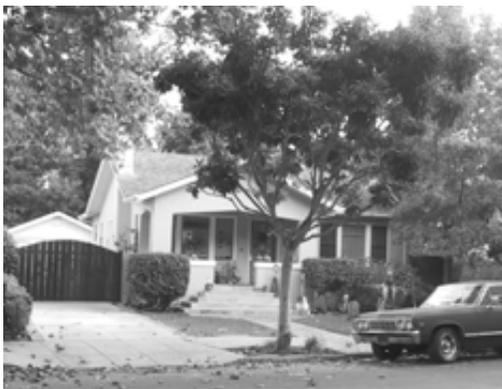
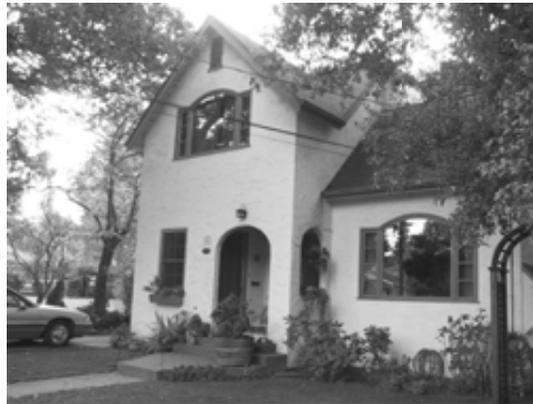
Figure 37: Finger Avenue houses

The proposed new homes are compatible in style, character and scale with the surrounding neighborhood. The proposed new homes adjacent to the Finger Farm House property do not further reduce its visibility from the public right-of-way and are distinct but compatible in design treatment. The proposed project does not create a significant adverse effect on the historic character of the Finger Farm House or the surrounding neighborhood.

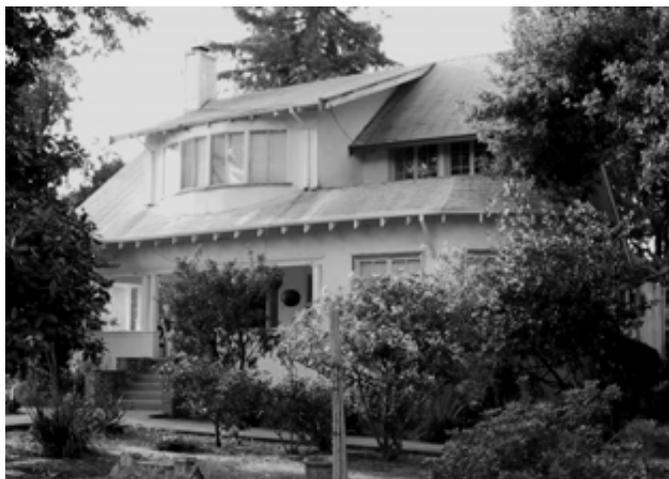
*P3a. Photograph

A two-story single-family residence (80 Finger Avenue) and three secondary residences (80a, 80b, 80c) on a single suburban lot located between Finger Avenue and Cordilleras Creek. The main structure is a two-story, side-gabled wood frame and stucco house. The house exhibits some Craftsman features, such as the wide entry porch, but is generally a weak example of the style. The 80a structure is a single-story, hipped-roof building with clapboard siding and a wood shingle roof. 80a contains a single-car garage and an attached one-room cottage with a series of shed additions to the rear (presumably bathroom and kitchen facilities). 80b is a small Craftsman-style bungalow with clapboard siding, wood shingle gabled roof, and a front porch extending the width of the house. The structure at 80c is single-story, with a shingled hipped roof and a carriage-style door as well as a second standard door, and a shed addition to the rear. All four structures are currently occupied as residences.
